Manhole Inspection Summary

Manhole # S17I__030MH

Insp Date: **3/31/08 1:52 PM**

Location Address: **2410 BALTIMORE ST**

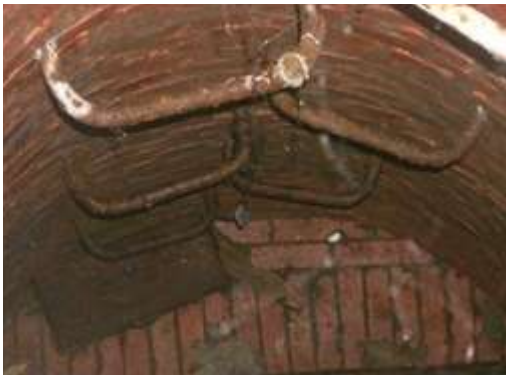
Defect 4

Steps Count: **8** Missing: **0** ☒ **Corroded**

CORRODED STEPS

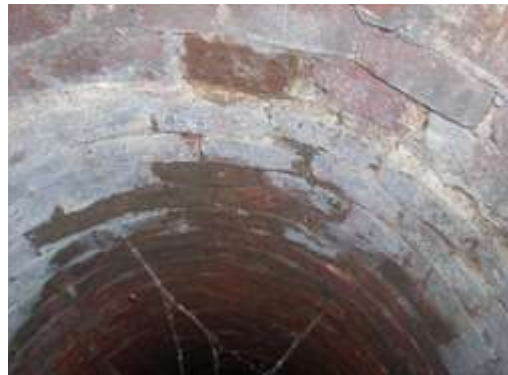
Defect 3

Infiltration: ☐ None ☐ Joint ☐ Cracks ☐ Mortar ☐ Roots ☒ **Wall**

INFILTRATION OF THE CORBEL WALL

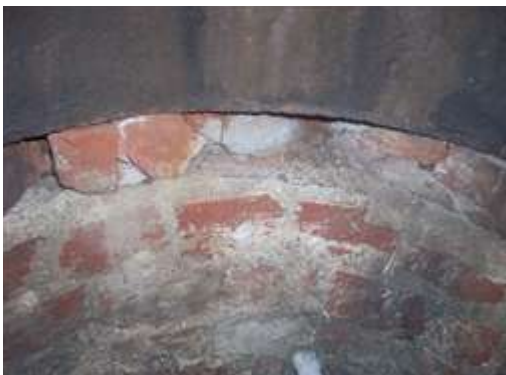
Defect 2

Condition: ☐ Sound ☐ Cracked ☐ Root Intrusion ☐ Loose Brick ☒ **Deteriorated**

DETERIORATED CHIMNEY

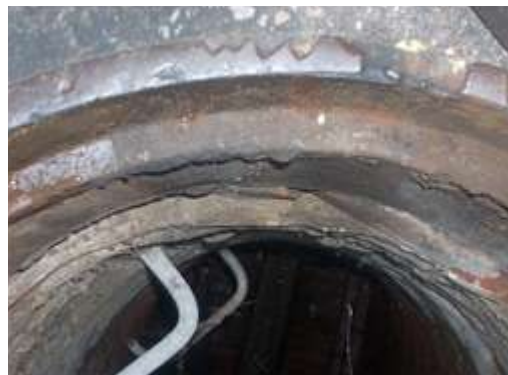
Defect 1

Frame Offset: **1** (in.) Condition: ☒ Sound ☐ Cracked ☐ Leaks

FRAME OFFSET

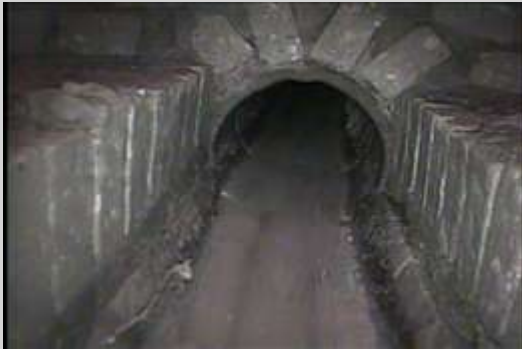
12 O'Clock Outflow

8 in. Circular Gravity Sewer
Pipe Out @ 12 O'Clock

Pipe Height: **7.2** (in.) Rod and Bar (Angled)
Pipe Material: **Clay** ☐ Pipe Lined
Invert Depth: **12.21** (ft.) Flow Characteristics: **Fast**
Deposits: ☒ None ☐ Mud ☐ Sludge ☐ Debris ☐ Grease
Silt Depth: (in.) Deposits Extent:
Infiltration: **None** Pipe Seal Cond: **Sound**

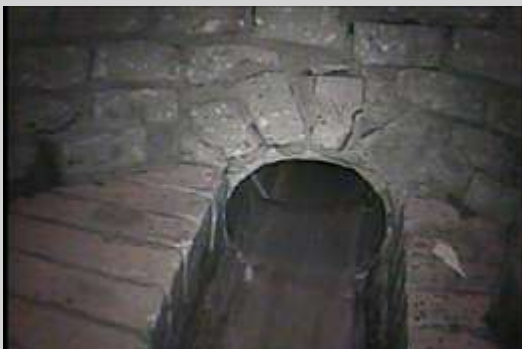
6 O'Clock Inflow

8 in. Circular Gravity Sewer
Pipe In @ 6 O'Clock

Pipe Height: **7.2** (in.) Rod and Bar (Angled)
Pipe Material: **Clay** ☐ Pipe Lined
Invert Depth: **11.94** (ft.) Flow Characteristics: **Fast**
Deposits: ☒ None ☐ Mud ☐ Sludge ☐ Debris ☐ Grease
Silt Depth: (in.) Deposits Extent:
Infiltration: **None** Pipe Seal Cond: **Sound**
